# Property Flood Resilience 2020 update

Stories from homes and businesses who have made adaptations to help them recover more quickly after a flood

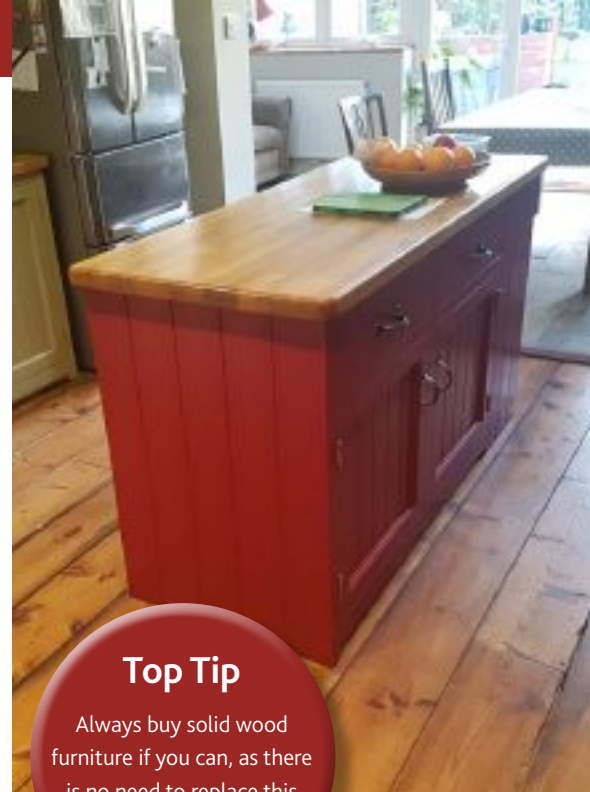
*Solid wood kitchen, easily washed down, and all parts are free-standing so moveable.*

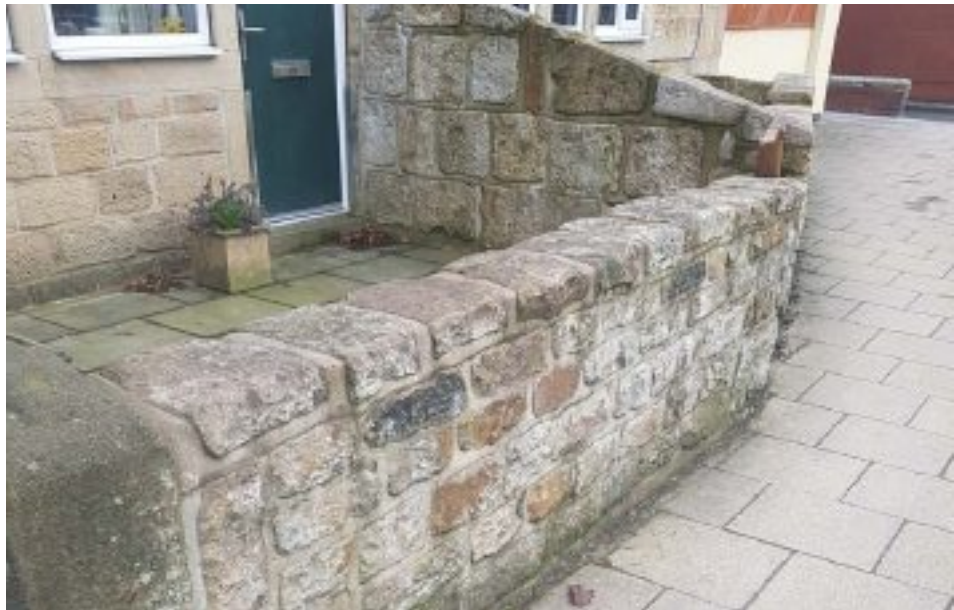
*New wall at front of house with a flood-proof gate*

Todmorden Resident told me that the flood water reached a good 20cm (8”) up the purpose-built wall and flood gate and it held fast. No insurance claim because there was no damage. Job done!

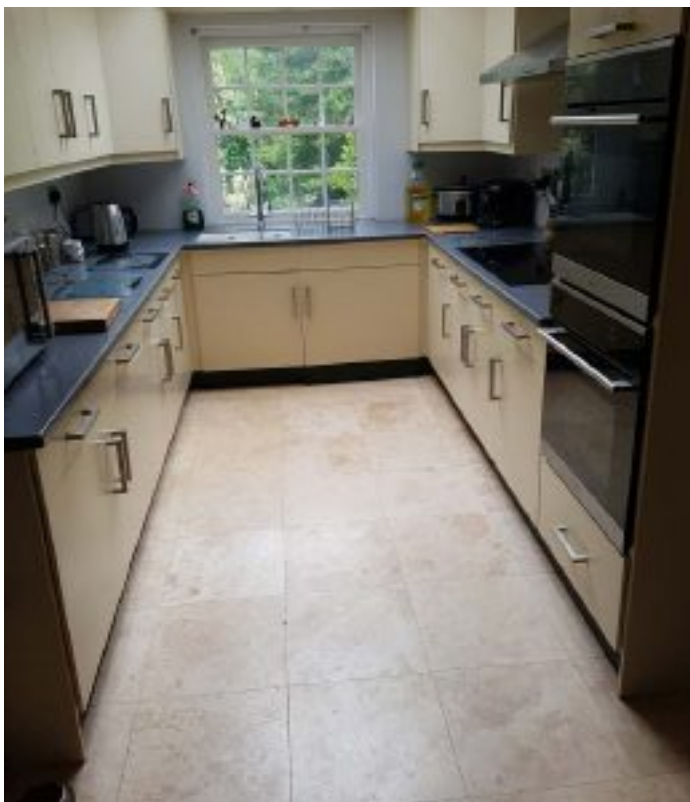
*A Corian plastic kitchen was fitted.*

He decided that because the kitchen was the most expensive item to replace, he would have a Corian plastic kitchen fitted. It appears that the company is no longer in existence, but a quick web search showed that Corian and laminated Aquoline kitchens are still available. He has stone tiled floors that survived the floods and now also has waterproof plaster on the walls.

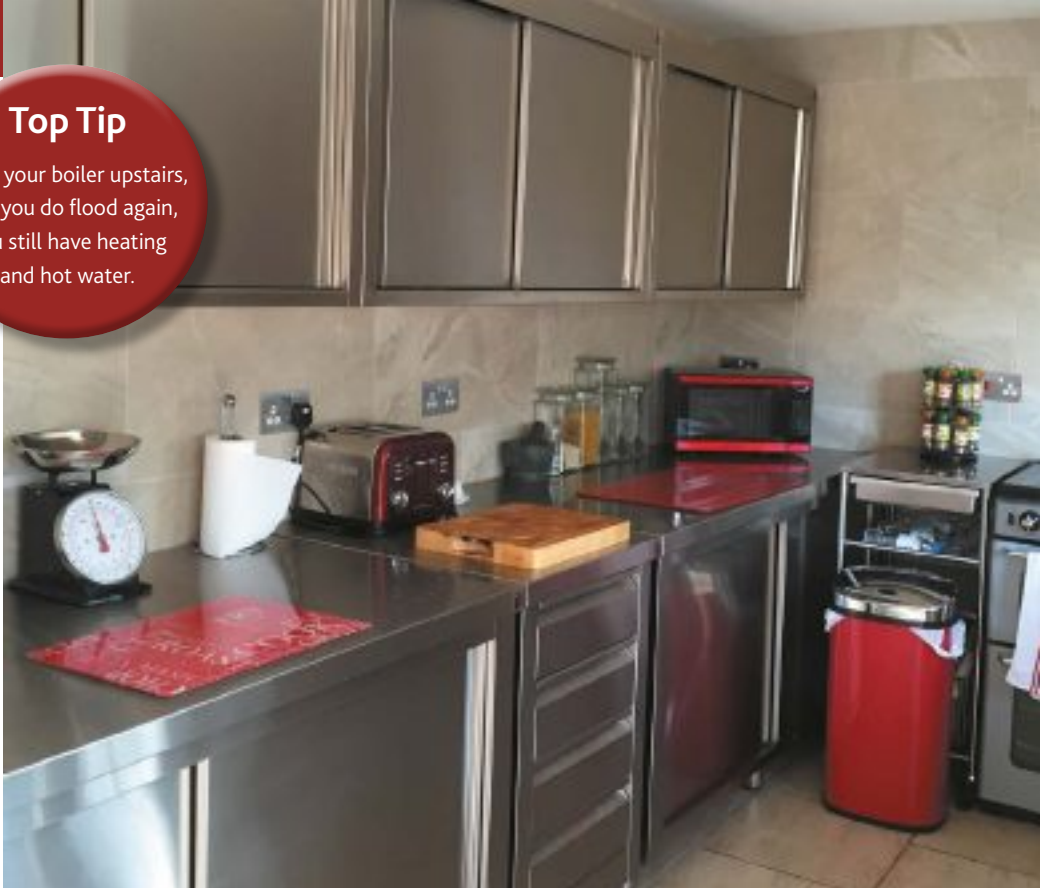
*Free-standing stainless steel kitchen with free-standing appliances.*

- Free-standing stainless steel kitchen with free-standing appliances, which can be moved to safety. The walls are tiled from floor to ceiling, using water-resistant cement and grout; internal door re-hung with hinges allowing it to be lifted off and moved upstairs.
- A flood-resistant door has been installed, which allows additional time for moving items before the water has to be let in.
- The ground floor is tiled throughout, using water resistant cement and grout – it can be hosed down and disinfected after a flood.
- The window sills are made of hardwood instead of the usual easily-damaged softwood.
- The fireplace surround is also made from hardwood, and has successfully survived a flood.

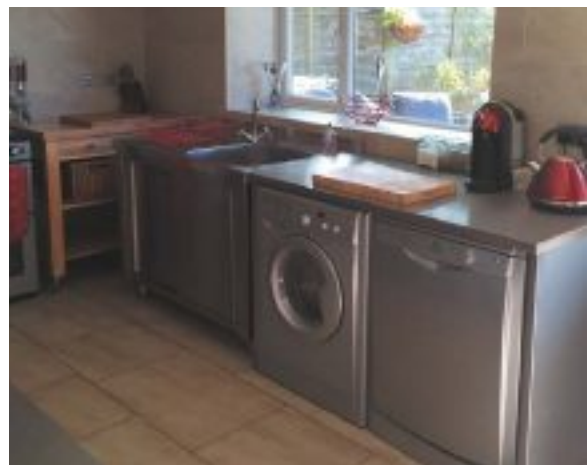
*The window sills are made of hardwood.*

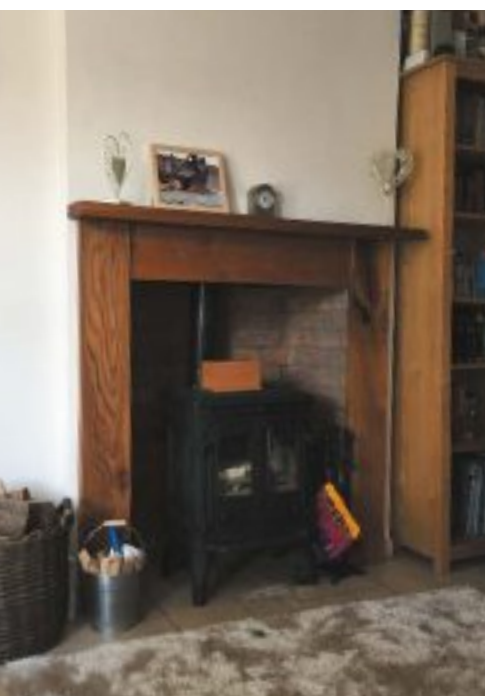
*The fireplace surround is also made from hardwood.*

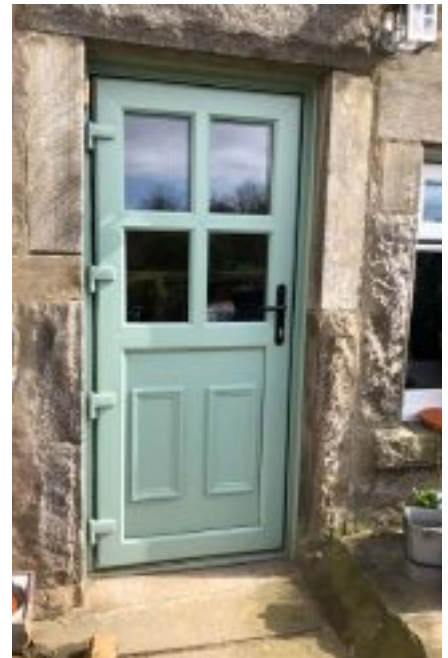
*Flood door fitted.*

- Kitchen moved upstairs.
- Replaced original window with a flood proof window.
- Fitted a flood door.
- Moved boiler up the wall.
- Isolate the electrics, so upstairs can continue to function during a flood.

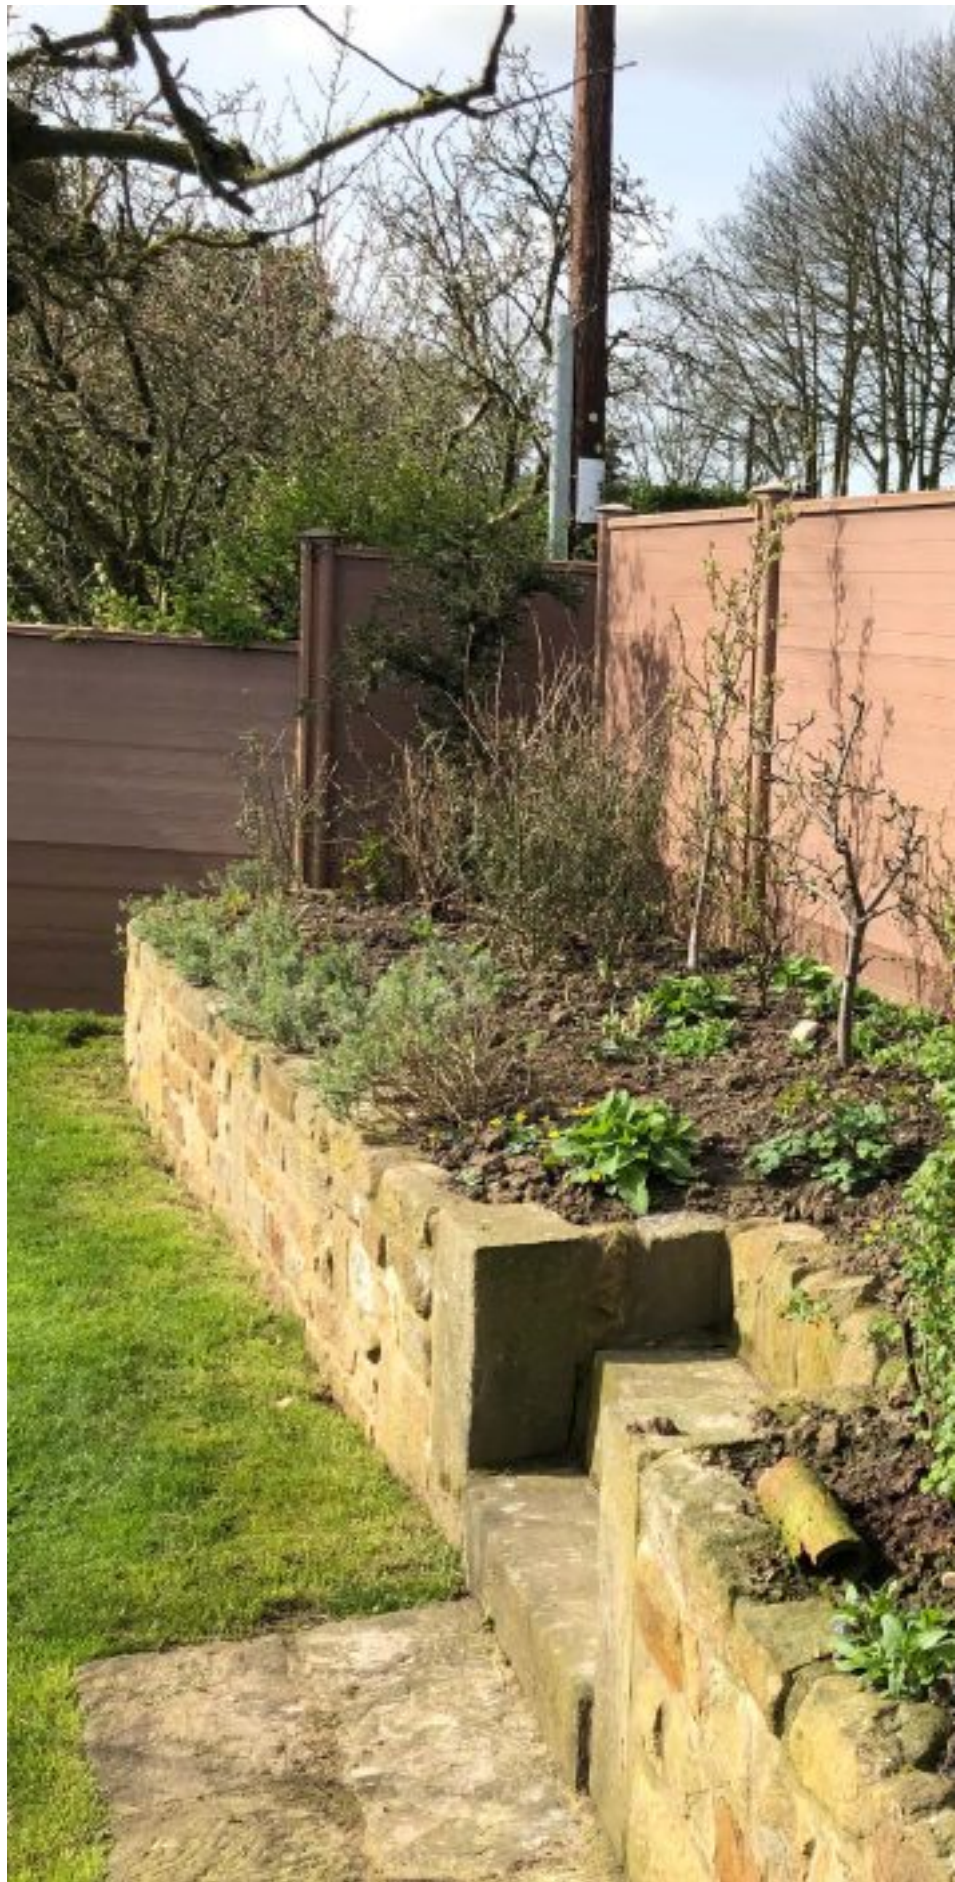
*At the perimeter of the garden one-metre-deep holes were filled with concrete, into which posts and reinforced 'Task Green' waterproof fence panels were fitted.*

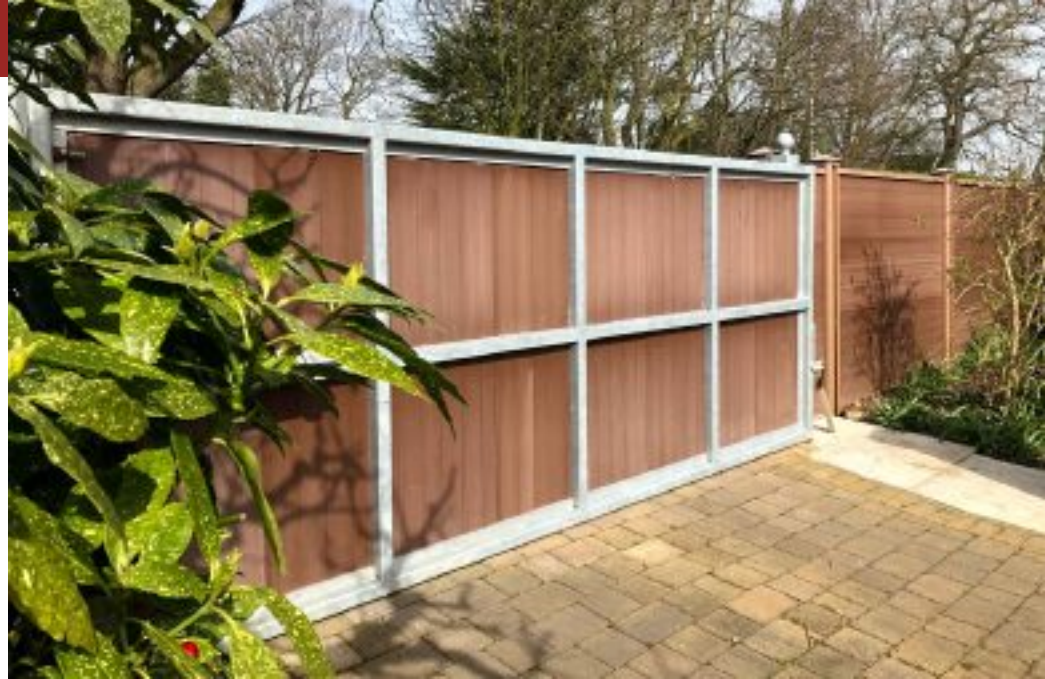
*The front entrance gate is the same material as the fence panels and is fitted tightly to prevent ingress of water.*

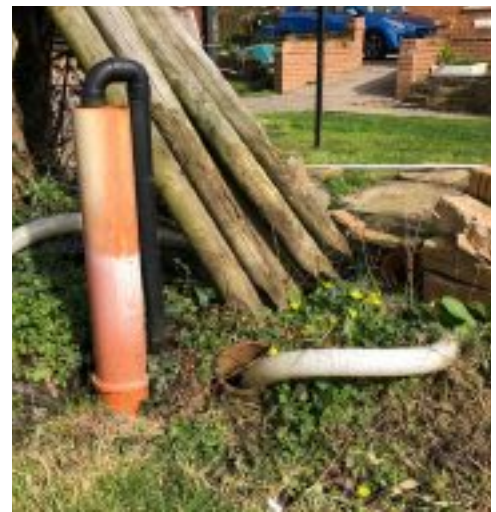
*Rainwater runs through a series of French drains into a large sump into which a strong pump is fitted which pumps the water outside the garden boundaries.*

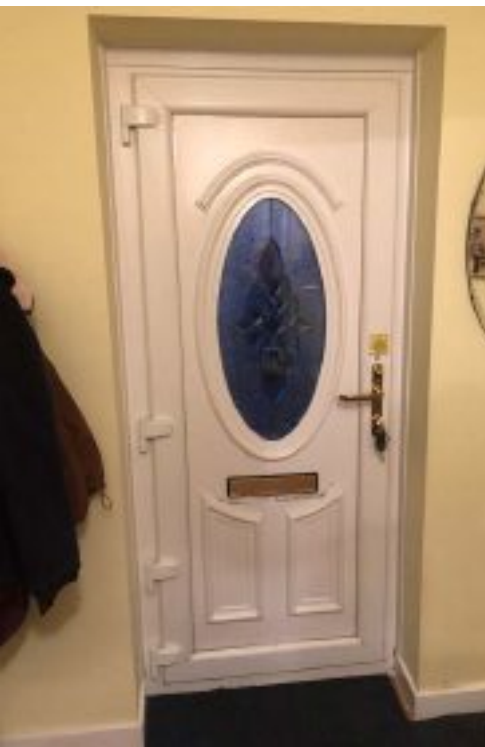
Flood resilient front door has been installed.

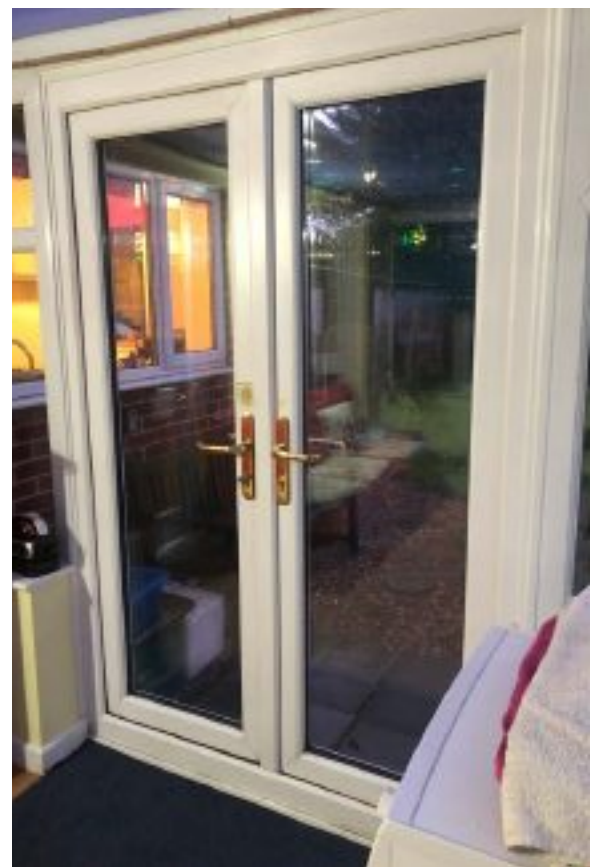
Flood resilient patio doors have been installed.

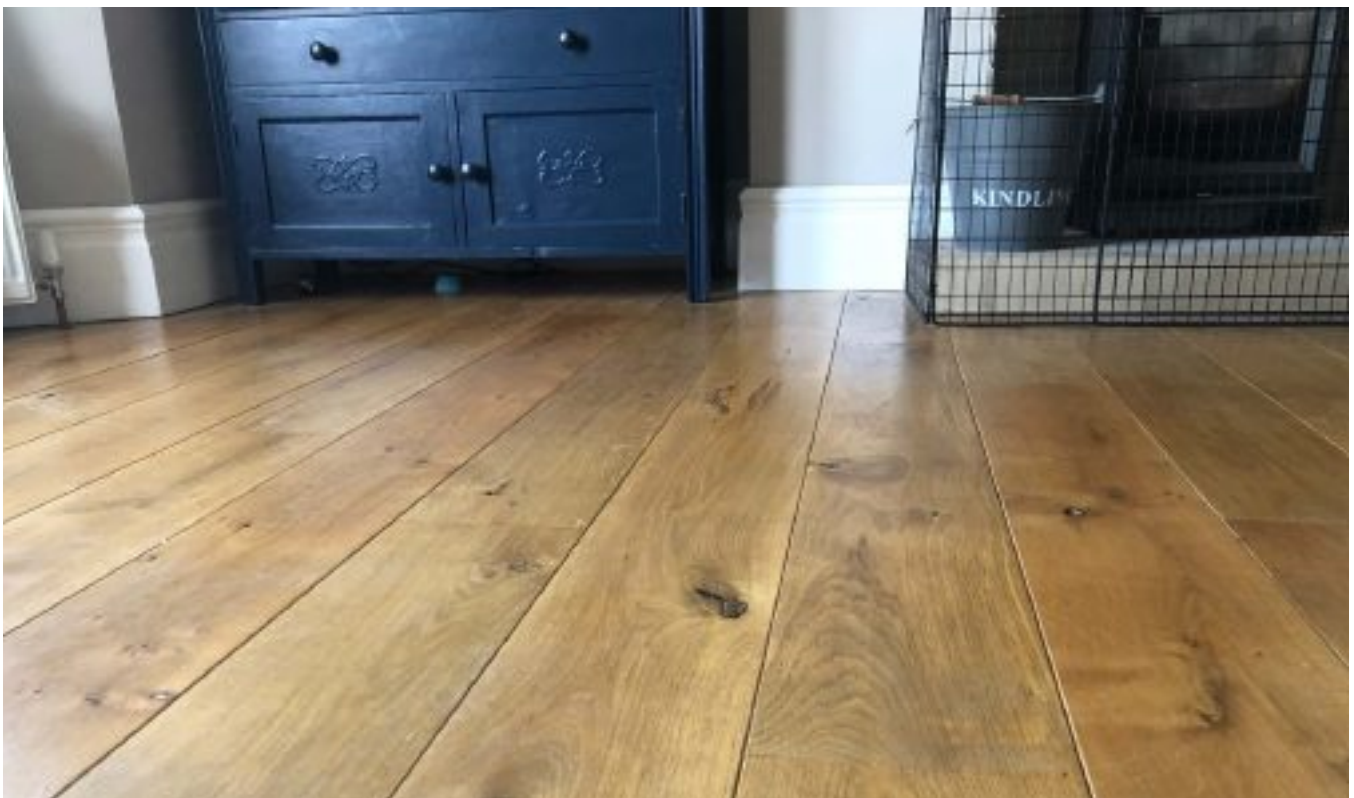
*Hard wood flooring with rugs replace the carpets which were a nightmare to lift out and dry following the flood.*

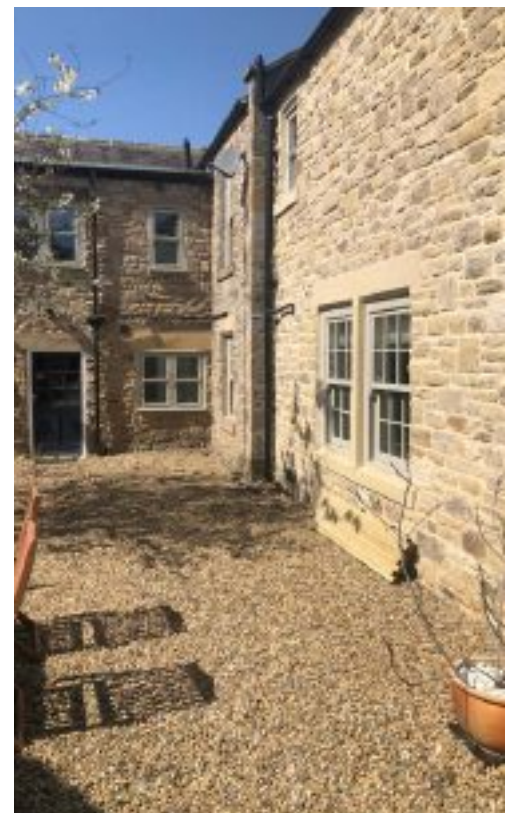
*Permeable patio areas surround most of the house.*

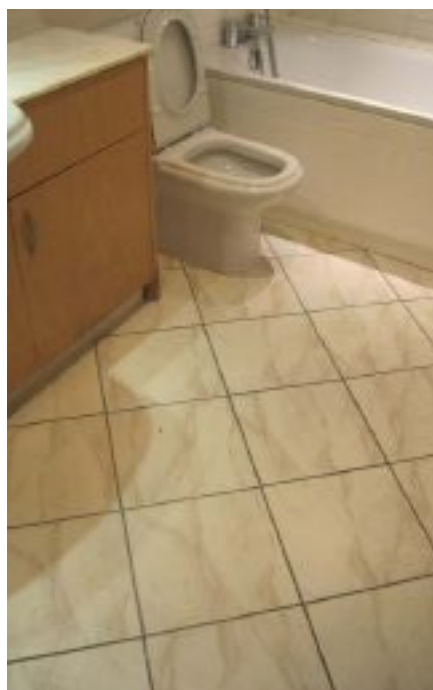
Ceramic tiled bathroom floor.

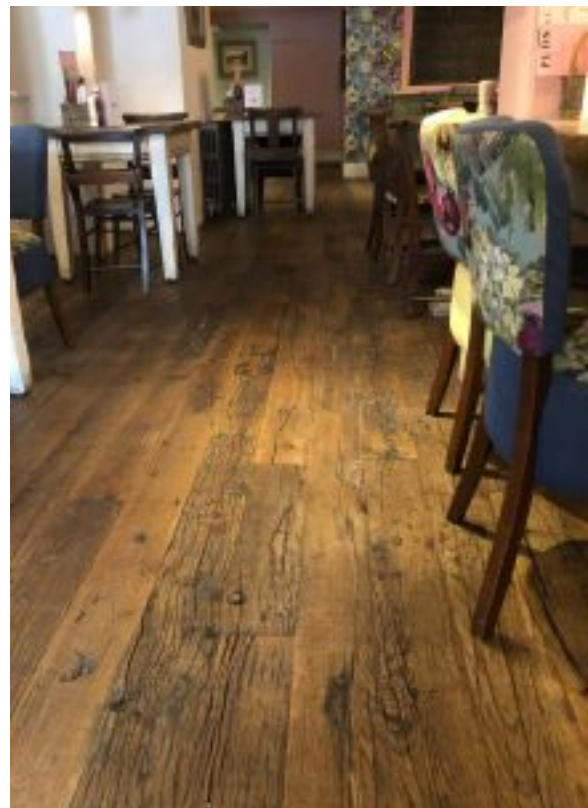
The bar is solid oak with stainless steel fittings and easily removable equipment.

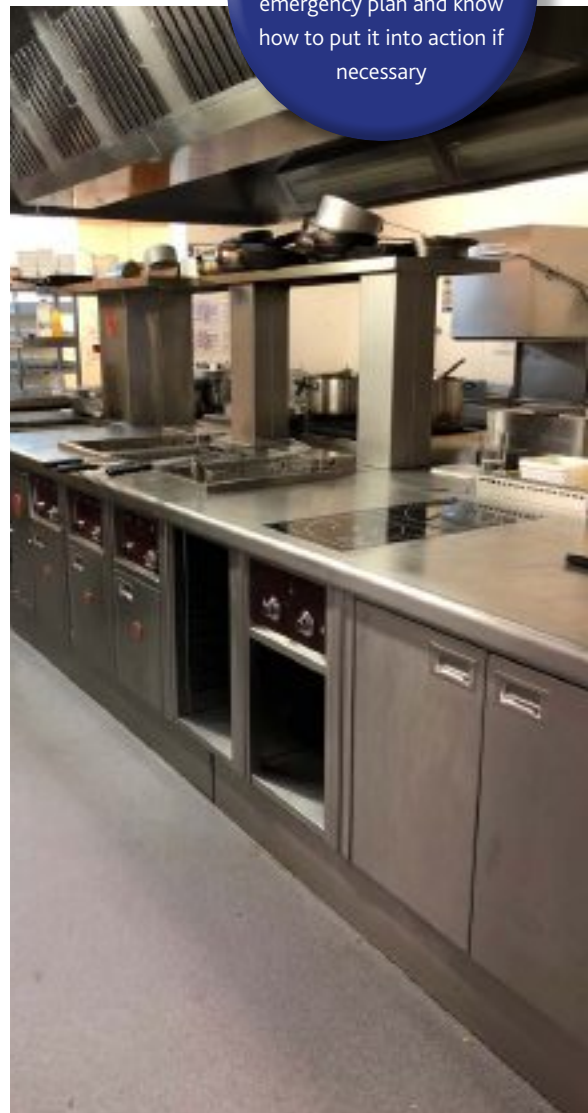
*The motor can be removed from the stainless-steel kitchen 'Chave block' (cooking area).*

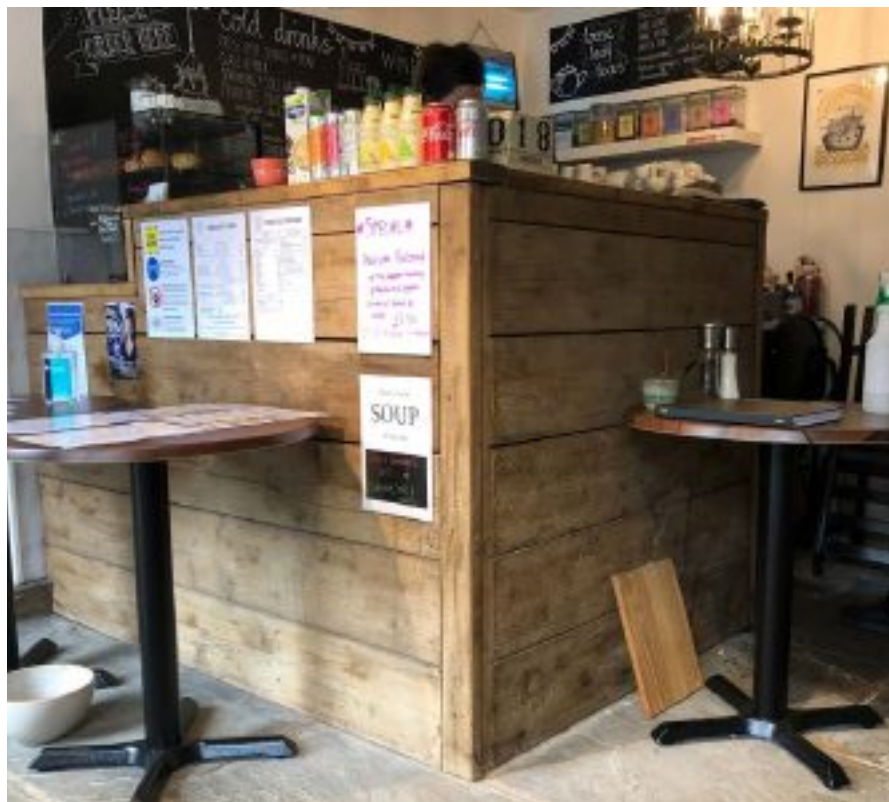
Main counter made of varnished scaffolding planks.
